Confidential Inspection Report
1234 Anywhere St.
Chicago IL 60631

May 16, 2019
Prepared for: John Doe

Inspection Table of Contents

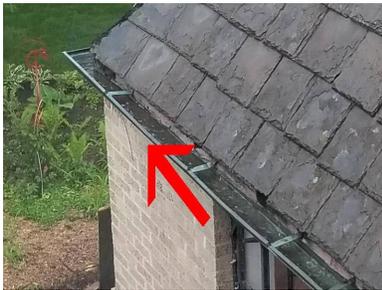
RECOMMEND REPAIRS AS NEEDED - Recommend cleaning the gutters and downspouts in order to facilitate proper drainage. Gutters are holding water. **Location of concern:** Multiple areas around the home.

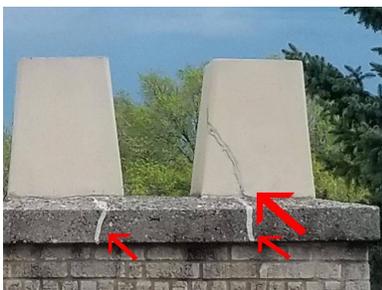
ATTENTION - Cracked chimney cap visible. Recommend adding a rain cap to deter water and animal penetration.

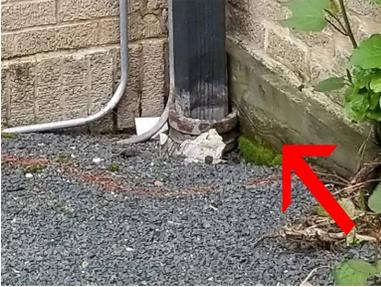
ATTENTION - Grading is pitched towards the home in areas. It is recommended that all grading be pitched away from the home to facilitate proper drainage and decrease the likelihood of seepage into the home in the areas below grade. **Location of concern:** Backyard. North, East.

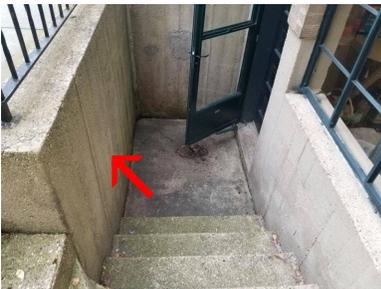
ATTENTION - No handrail installed in stairwell. Recommend adding a handrail for safety.

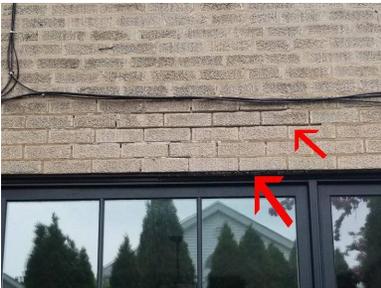
RECOMMEND REPAIRS AS NEEDED - Tuck-pointing needs attention in areas: Deteriorated mortar joints are visible. Visible step cracks noted in the mortar joints. **Location of concern:** Multiple Areas.

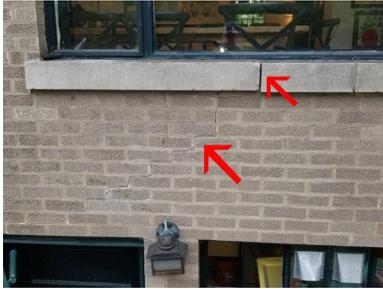
RECOMMEND REPAIRS AS NEEDED - Tuck-pointing needs attention in areas: Visible step cracks noted in the mortar joints.

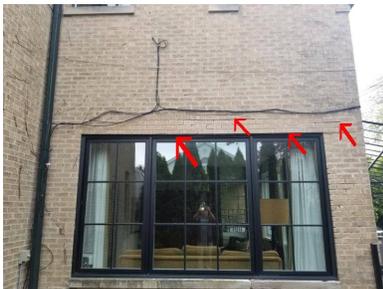
ATTENTION - Rusted lintel(s) are visible. Sagging lintel(s) are visible. **Location of concern:** North, East.

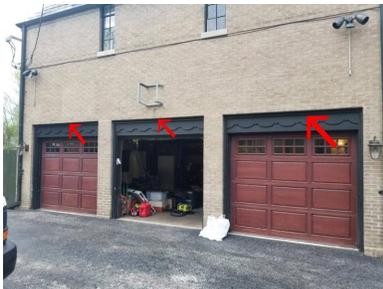
ATTENTION - Sagging lintel(s) are visible. **Location of concern:** Overhead garage doors.

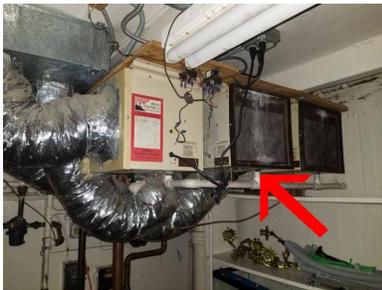
ATTENTION - The humidifier system appears to be older. An older humidifier can fail at any time. The humidifier system appears to lack maintenance. The unit needs to be cleaned, serviced and evaluated.

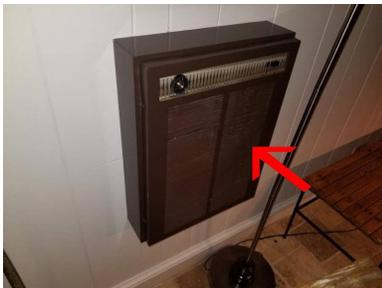
ATTENTION - At least one heating unit is older. Older heating units can fail at any time. Systems does not appear to be adequately heating. Located in basement pool table area.

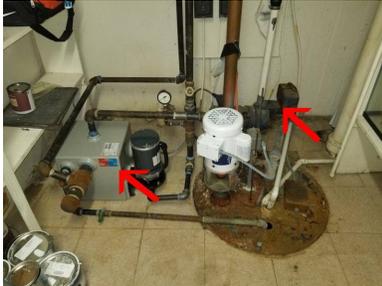
ATTENTION - Request explanation and demonstration of pump system in basement in and around sump pump by current owner.

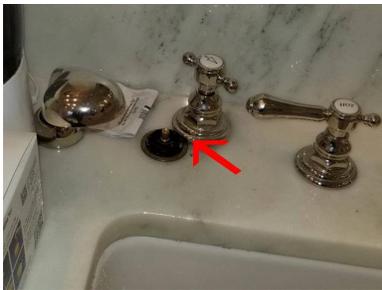
RECOMMEND REPAIRS AS NEEDED - Diverter for tub is in disrepair and leaking. Water comes from both sprayer and tub filler.

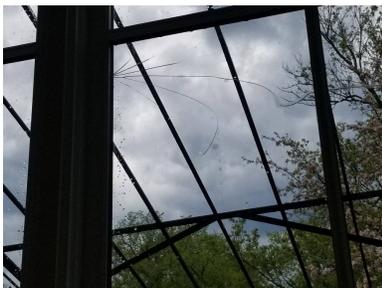
RECOMMEND REPAIRS AS NEEDED - There is at least one broken window pane.

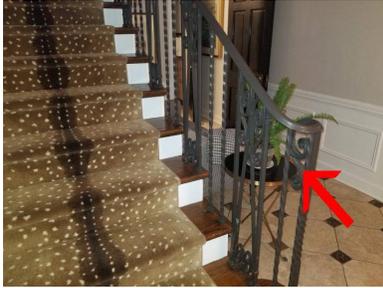
RECOMMEND REPAIRS AS NEEDED - Loose handrail noted. **Location of concern:** 1st to 2nd Floor Stairway. Main entry foyer.

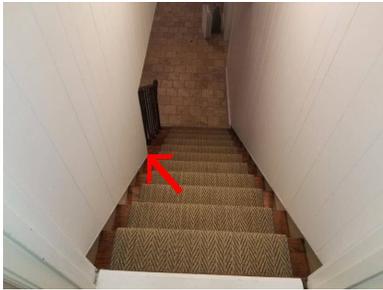
RECOMMEND REPAIRS AS NEEDED - Partial railing system is installed. Recommend installation of additional handrail as needed. **Location of concern:** Basement stairway.

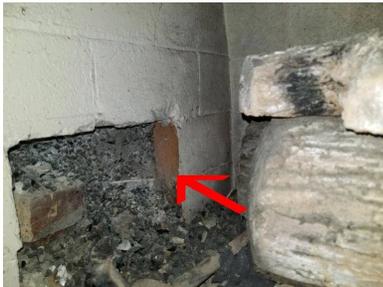
RECOMMEND REPAIRS AS NEEDED - Large void visible in firebox.

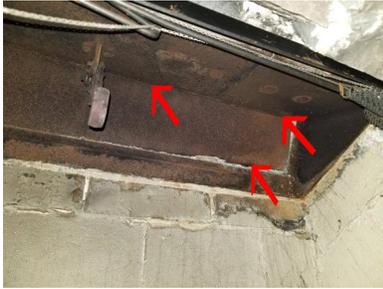
RECOMMEND REPAIRS AS NEEDED - Gaps visible when damper is closed.

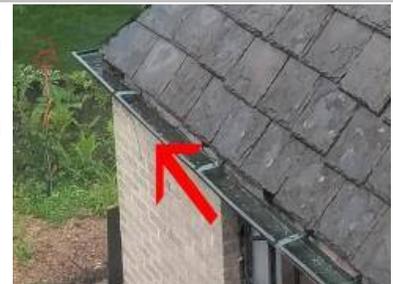
Gutters: **RECOMMEND REPAIRS AS NEEDED** - Recommend cleaning the gutters and downspouts in order to facilitate proper drainage. Gutters are holding water. **Location of concern:** Multiple areas around the home.

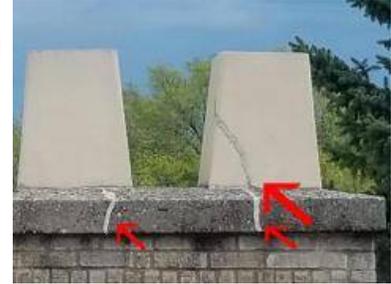
Chimney Location: East.
Chimney Material: Brick.
Chimney Liner Installed? **ATTENTION** - There does not appear to be a chimney liner installed. Installation of a chimney liner may or may not be indicated based on the age and efficiency of the mechanicals venting into it. This determination should be made by a qualified HVAC contractor.
Chimney Condition: **ATTENTION** - Cracked chimney cap visible. Recommend adding a rain cap to deter water and animal penetration.

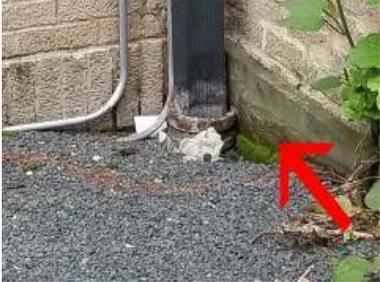
<i>Sidewalks:</i>	APPEARS SERVICEABLE - Visible portion of sidewalk(s) appear in acceptable condition at this time. Cracks & settlement noted are typical.
<i>Driveway:</i>	APPEARS SERVICEABLE - Visible portion of the driveway appears in acceptable condition at this time. Cracks & settlement noted are typical.
<i>Patio:</i>	APPEARS SERVICEABLE - Visible portion of the patio(s) appears in acceptable condition at this time. Cracks & settlement noted are typical.
<i>Paver Steps/Stoops:</i>	APPEARS SERVICEABLE - Visible portion of the paver steps/stoops appear in acceptable condition at this time. Cracks & settlement noted are typical.
<i>Grading/Drainage:</i>	ATTENTION - Grading is pitched towards the home in areas. It is recommended that all grading be pitched away from the home to facilitate proper drainage and decrease the likelihood of seepage into the home in the areas below grade. Location of concern: Backyard. North, East.

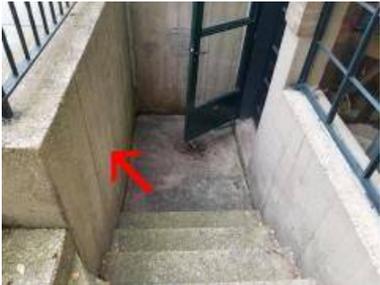
<i>Vegetation:</i>	APPEARS SERVICEABLE - The visible vegetation appears in acceptable condition at this time.
<i>Basement Stairwell:</i>	ATTENTION - No handrail installed in stairwell. Recommend adding a handrail for safety.

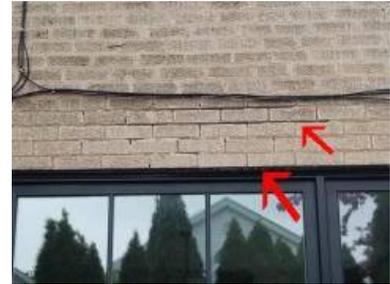
RECOMMEND REPAIRS AS NEEDED - Tuck-pointing needs attention in areas: Deteriorated mortar joints are visible. Visible step cracks noted in the mortar joints. **Location of concern:** Multiple Areas.

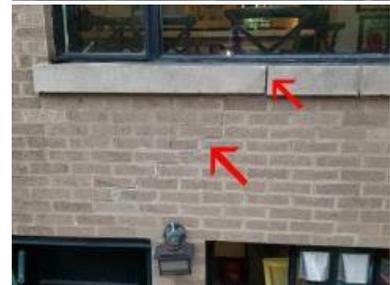
RECOMMEND REPAIRS AS NEEDED - Tuck-pointing needs attention in areas: Visible step cracks noted in the mortar joints.

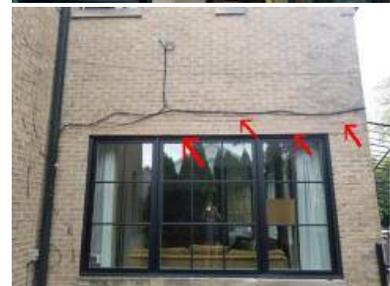
ATTENTION - Rusted lintel(s) are visible. Sagging lintel(s) are visible. **Location of concern:** North, East.

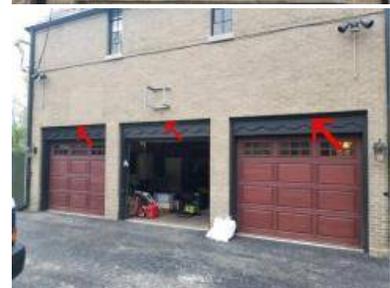
ATTENTION - Sagging lintel(s) are visible. **Location of concern:** Overhead garage doors.

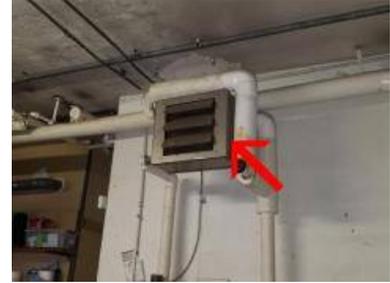
APPEARS SERVICEABLE - Heating system was functional at the time of inspection using normal controls and the production of heat was confirmed. Older heating system present in garage. Older heating system components can fail at any time.

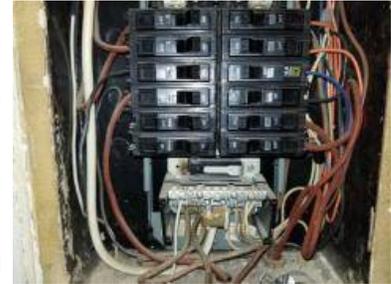
APPEARS SERVICEABLE - Electrical panel appears in overall acceptable condition. Circuit and wire sizing correct so far as visible. It is not always possible to determine wire gauge when labeling on wire is not visible. **ATTENTION** - Older wiring is visible within the panel. It may be desirable to update old wiring.

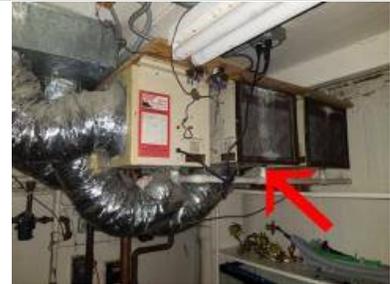
Humidifier (Issues): **ATTENTION** - The humidifier system appears to be older. An older humidifier can fail at any time. The humidifier system appears to lack maintenance. The unit needs to be cleaned, serviced and evaluated.

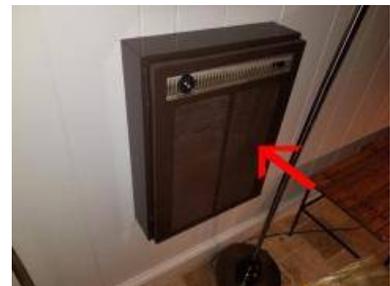
Heating Units/System Operation/Condition: **ATTENTION** - At least one heating unit is older. Older heating units can fail at any time. Systems does not appear to be adequately heating. Located in basement pool table area.

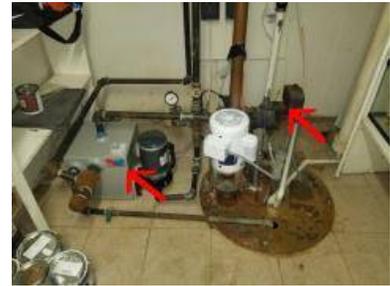
<i>Sump Pump Battery Back-Up:</i>	ATTENTION - Recommend installing a suitable battery back-up system or generator for the sump pump to keep the pump functional in the event of a power outage.
<i>Additional Observations:</i>	ATTENTION - Request explanation and demonstration of pump system in basement in and around sump pump by current owner.

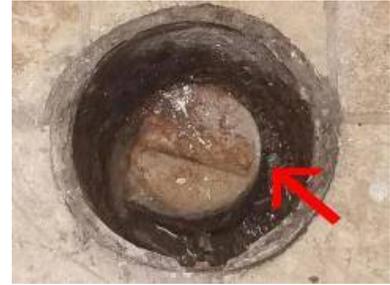
ATTENTION - Water appears to be backing up into floor drain in the area of the boiler and in the laundry area. This may be acceptable with this type of drain configuration. This should be confirmed by a qualified plumbing contractor.

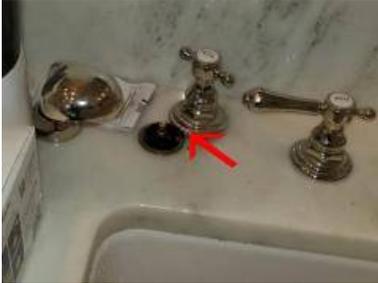
<i>Vanity Cabinet/Counter/Mirror :</i>	APPEARS SERVICEABLE - Vanity cabinet(s)/countertop/sink appears in acceptable condition.
<i>Bath Tub & Surround:</i>	APPEARS SERVICEABLE - The condition of the bath tub and surround walls appear to be in acceptable condition.
<i>Shower Pan & Surround:</i>	APPEARS SERVICEABLE - The condition of the shower pan and surround walls appear to be in acceptable condition. The shower pan is not flood tested.
<i>Water Pressure:</i>	APPEARS SERVICEABLE - Acceptable water pressure was observed at all plumbing fixtures in this bathroom. This is in the opinion of the inspector and your opinion may differ.
<i>Plumbing Drains:</i>	APPEARS SERVICEABLE - All drains in this bathroom appear to be functional with no visible leakage noted.
<i>Plumbing Fixtures:</i>	RECOMMEND REPAIRS AS NEEDED - Diverter for tub is in disrepair and leaking. Water comes from both sprayer and tub filler.

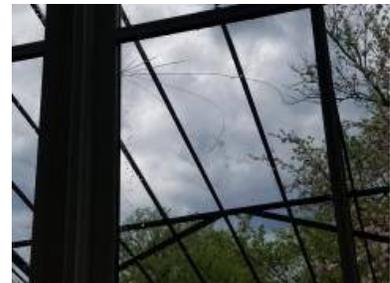
<i>Walls:</i>	APPEARS SERVICEABLE - Visible portions of the walls appear in acceptable condition.
<i>Ceiling:</i>	APPEARS SERVICEABLE - The visible portions of the ceiling appear in acceptable condition.
<i>Flooring:</i>	APPEARS SERVICEABLE - The visible portion of the flooring is in acceptable condition.
<i>Interior Doors:</i>	APPEARS SERVICEABLE - The interior door(s) appear in acceptable condition and are functional.
<i>Exterior Entry Door(s):</i>	APPEARS SERVICEABLE - The exterior entry door(s) appear in acceptable condition at this time.
<i>Windows:</i>	RECOMMEND REPAIRS AS NEEDED - There is at least one broken window pane.

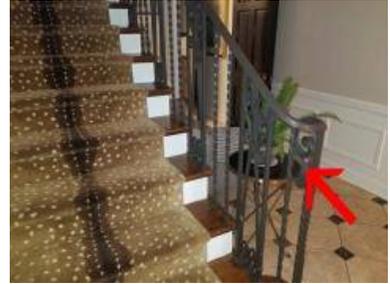
Location of concern: 1st to 2nd Floor Stairway. Main entry foyer.

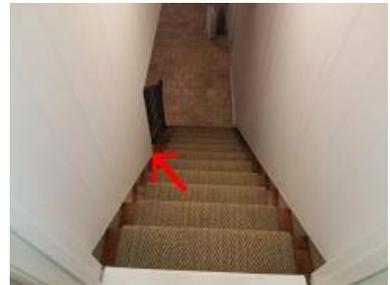
RECOMMEND REPAIRS AS NEEDED - Partial railing system is installed. Recommend installation of additional handrail as needed. **Location of concern:** Basement stairway.

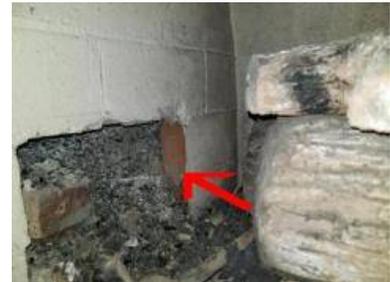
<i>Fireplace Type:</i>	Gas Log Fireplace.
<i>Fireplace</i>	Masonry.
<i>Material/Construction:</i>	
<i>Fireplace Condition:</i>	RECOMMEND REPAIRS AS NEEDED - Large void visible in firebox.

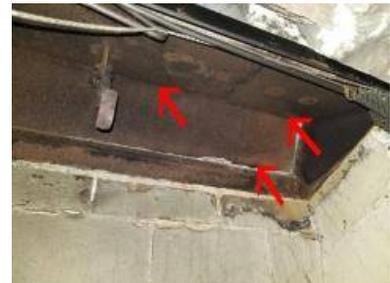
<i>Fireplace Damper:</i>	RECOMMEND REPAIRS AS NEEDED - Gaps visible when damper is closed.
--------------------------	--
